# Tank 5 Quarterly Release Response Report

## Red Hill Bulk Fuel Storage Facility

JBPHH, Oahu, Hawaii

April 2016

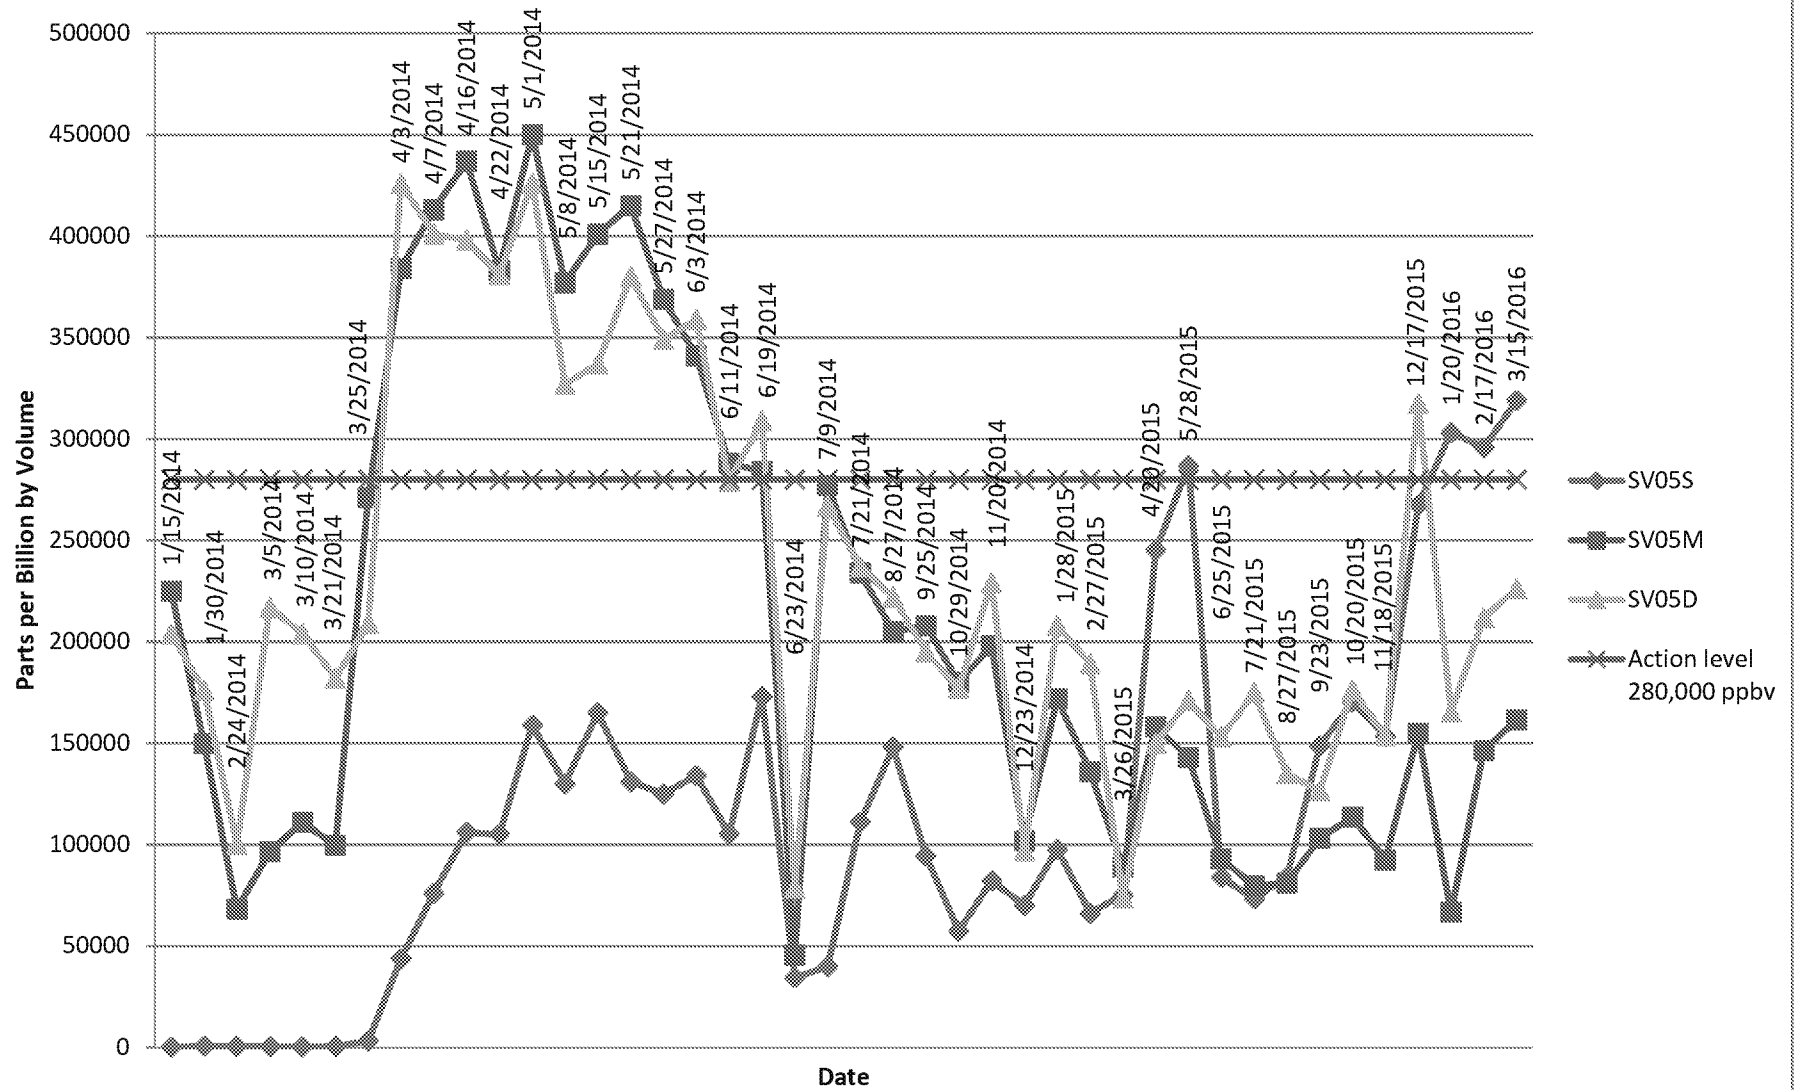
**Figure 4**  
**Soil Vapor Measurements**  
**SV05**

Soil vapor monitoring was performed at all active and accessible tanks in January, February, and March 2016. Soil vapor VOC concentrations at Tank 5 were above the action level of 280,000 ppbv during the January, February, and March monitoring events. Soil vapor VOC concentrations at all other active and accessible tanks were about 10 to 600 times below the action levels, with no consistent trending.
